# X-RAY TOPOGRAPHY STUDY OF COMPLEX SILICON MICROCIRCUITS

FINAL REPORT  
FOR NASA/MSFC CONTRACT NO. NAS8-33519

April 1981

D. L. Parker

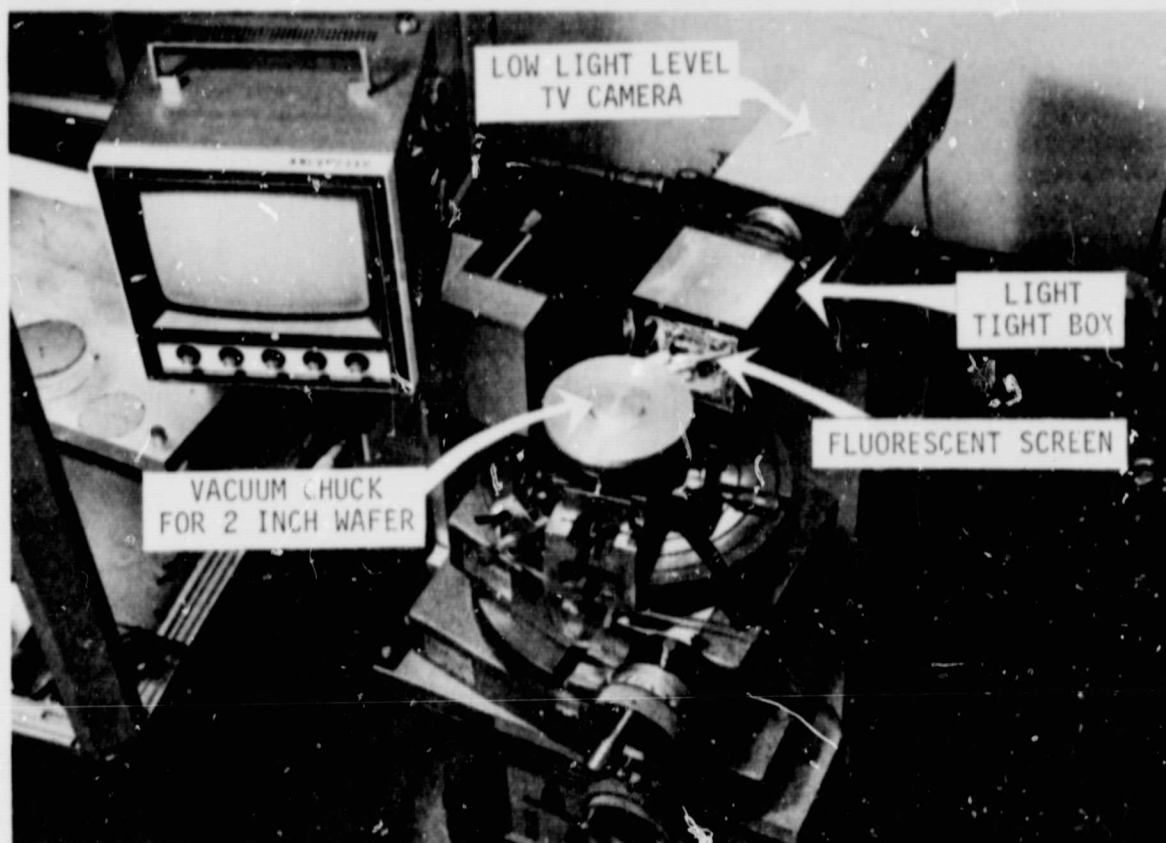
Fig. 2 x-ray topographic camera with 2 inch curved chuck attached. The chuck rotation assembly is tilted to the wafer load position. The  $\theta$  and  $2\theta$  positions are typical of those used in reflection x-ray topography.

All of the critical moving parts of the camera were adapted from standard machine tool equipment. These include a 15" rotary table, a 12" rotary table and a dividing head. These parts are very accurate, rugged, and inexpensive when compared to commercial x-ray equipment. The dividing head can accommodate a variety of interchangeable chucks of different sizes and curvatures. Indeed the dividing head was used to machine the chucks in a milling machine! The dividing head was modified to adapt a vacuum slip ring assembly and spring loaded detents at the horizontal (wafer load) and vertical (operate) positions.
